# Manhole Inspection Summary

Manhole # S69O\_\_010MH

Insp Date: **4/11/08 2:20 PM**

**Location** Address: **6706 Youngstown Ave.**

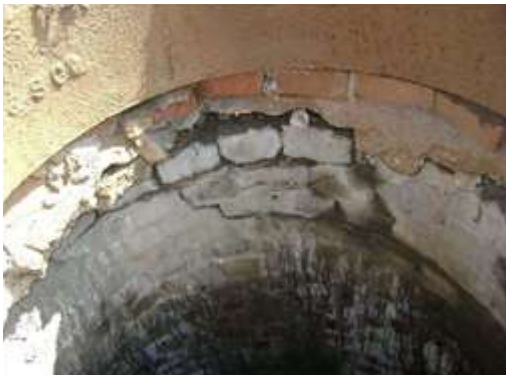
Defect 2

Condition: ☐ Sound ☐ Cracked ☐ Root Intrusion ☒ Loose Brick ☒ Deteriorated

Loose Bricks

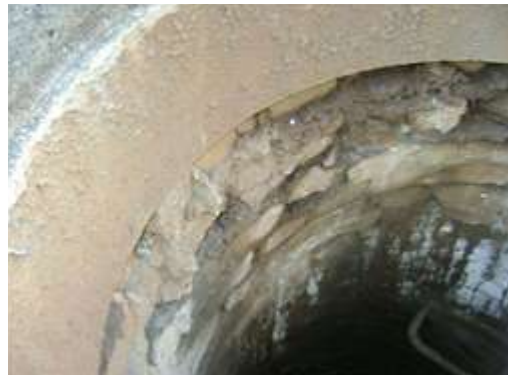
Defect 3

Infiltration: ☐ None ☒ Joint ☐ Cracks ☒ Mortar ☐ Roots ☐ Wall

Infiltration: ☐ None ☐ Joint ☐ Cracks ☒ Mortar ☐ Roots ☐ Wall

Infiltration-barrel wall---chimney joints

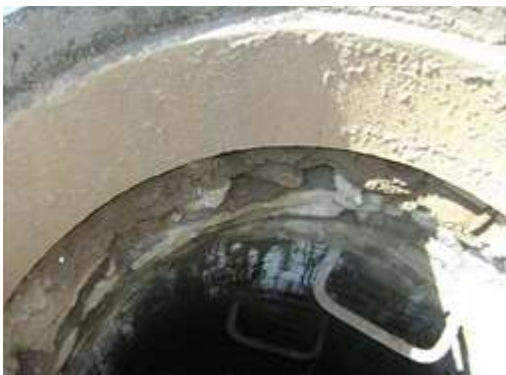
Defect 1

Condition: ☐ Sound ☐ Cracked ☐ Root Intrusion ☐ Loose Brick ☒ Deteriorated

Deterioration

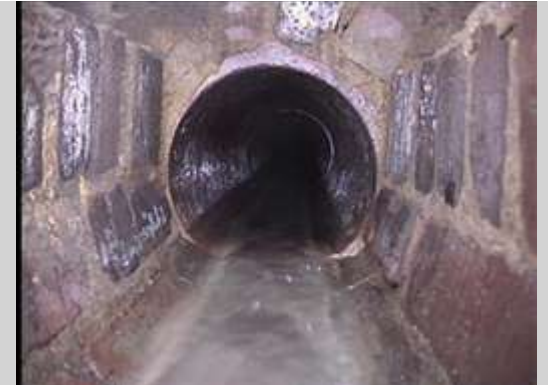
12 O'Clock Outflow

8 in. Circular Gravity Sewer  
Pipe Out @ 12 O'Clock

Pipe Height: **8.4** (in.) Rod and Bar (Angled)  
Pipe Material: **Clay** ☐ Pipe Lined  
Invert Depth: **7.00** (ft.) Flow Characteristics: **Fast**  
Deposits: ☒ None ☐ Mud ☐ Sludge ☐ Debris ☐ Grease  
Silt Depth: (in.) Deposits Extent:  
Infiltration: **None** Pipe Seal Cond: **Sound**

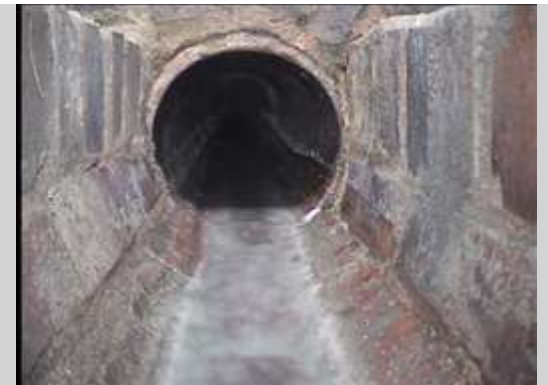
6 O'Clock Inflow

8 in. Circular Gravity Sewer  
Pipe In @ 6 O'Clock

Pipe Height: **8.4** (in.) Rod and Bar (Angled)  
Pipe Material: **Clay** ☐ Pipe Lined  
Invert Depth: **6.92** (ft.) Flow Characteristics: **Fast**  
Deposits: ☒ None ☐ Mud ☐ Sludge ☐ Debris ☐ Grease  
Silt Depth: (in.) Deposits Extent:  
Infiltration: **None** Pipe Seal Cond: **Sound**
